New York State Department of Transportation

Yellow Flag NB23U4W005

BIN: 1065318

Feature Carried: 278I278IX2M23027

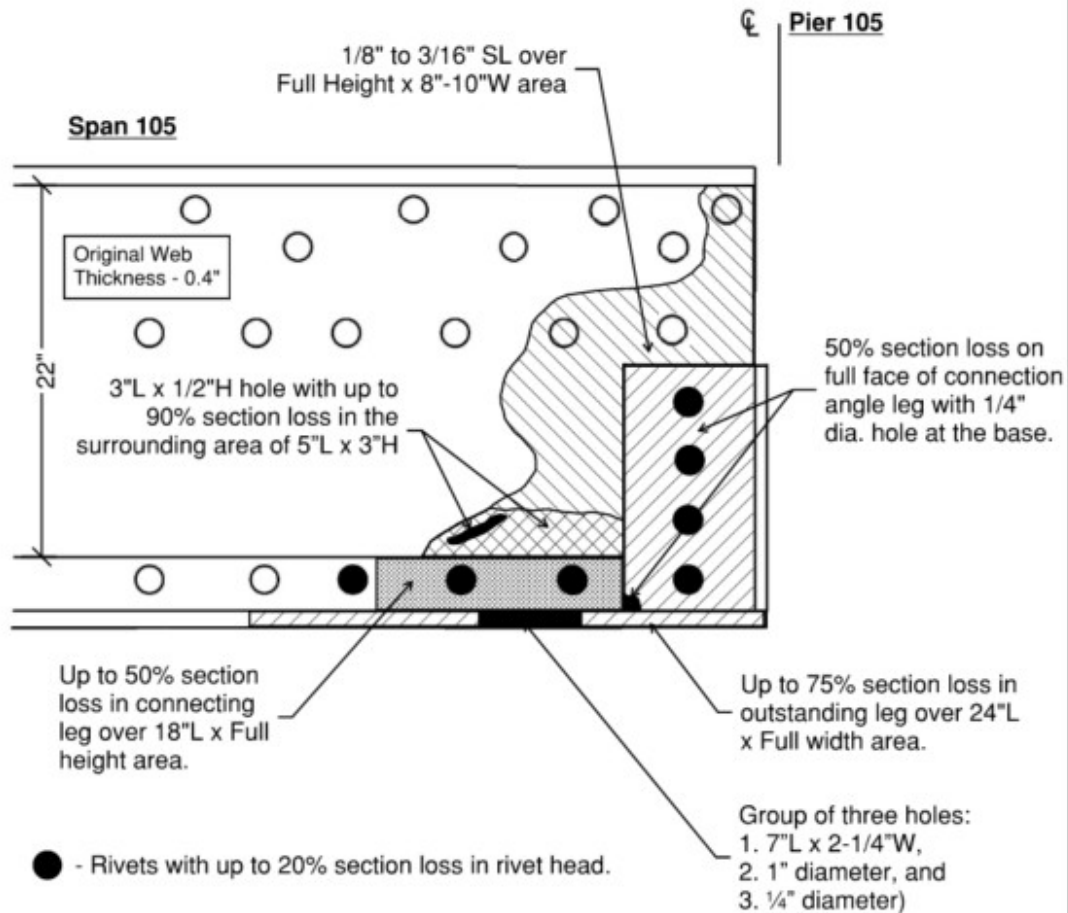
Photo Number: 2

Stringer S2 right face at Pier 105 exhibits heavy section loss in the web, varying from 1/8" to 3/16" over an area of 8" - 10" W x Full Height (22" H). There is a 3"L x 1/2"H hole in the lower web with up to 90% section loss in the surrounding area of 5"L x 3"H. The bottom flange angle on the right side exhibits up to 75% section loss in the outstanding leg (FW x 24"L) with three holes (7"L x 2-1/4"W, 1" diameter and 1/4" diameter) near the stringer seat. The connecting leg of the bottom flange angle on the right side exhibits up to 50% section loss (18"L x FH). The connection angle on the right face has up to 50% section loss over the full face of the connecting leg with 1/4" diameter edge hole at the base. All rivets in the connection angle and 3 rivets in the stringer seat bottom flange right angle exhibits up to 20% section loss in rivet heads. Additionally, 4 rivet heads on the connection angle on left face exhibit 50% section loss. Refer to sketch for further details.

SKETCH FOR YELLOW FLAG # NB23U4W005
SPAN 105, STRINGER S2 AT PIER 105
(LOOKING LEFT)
N.T.S

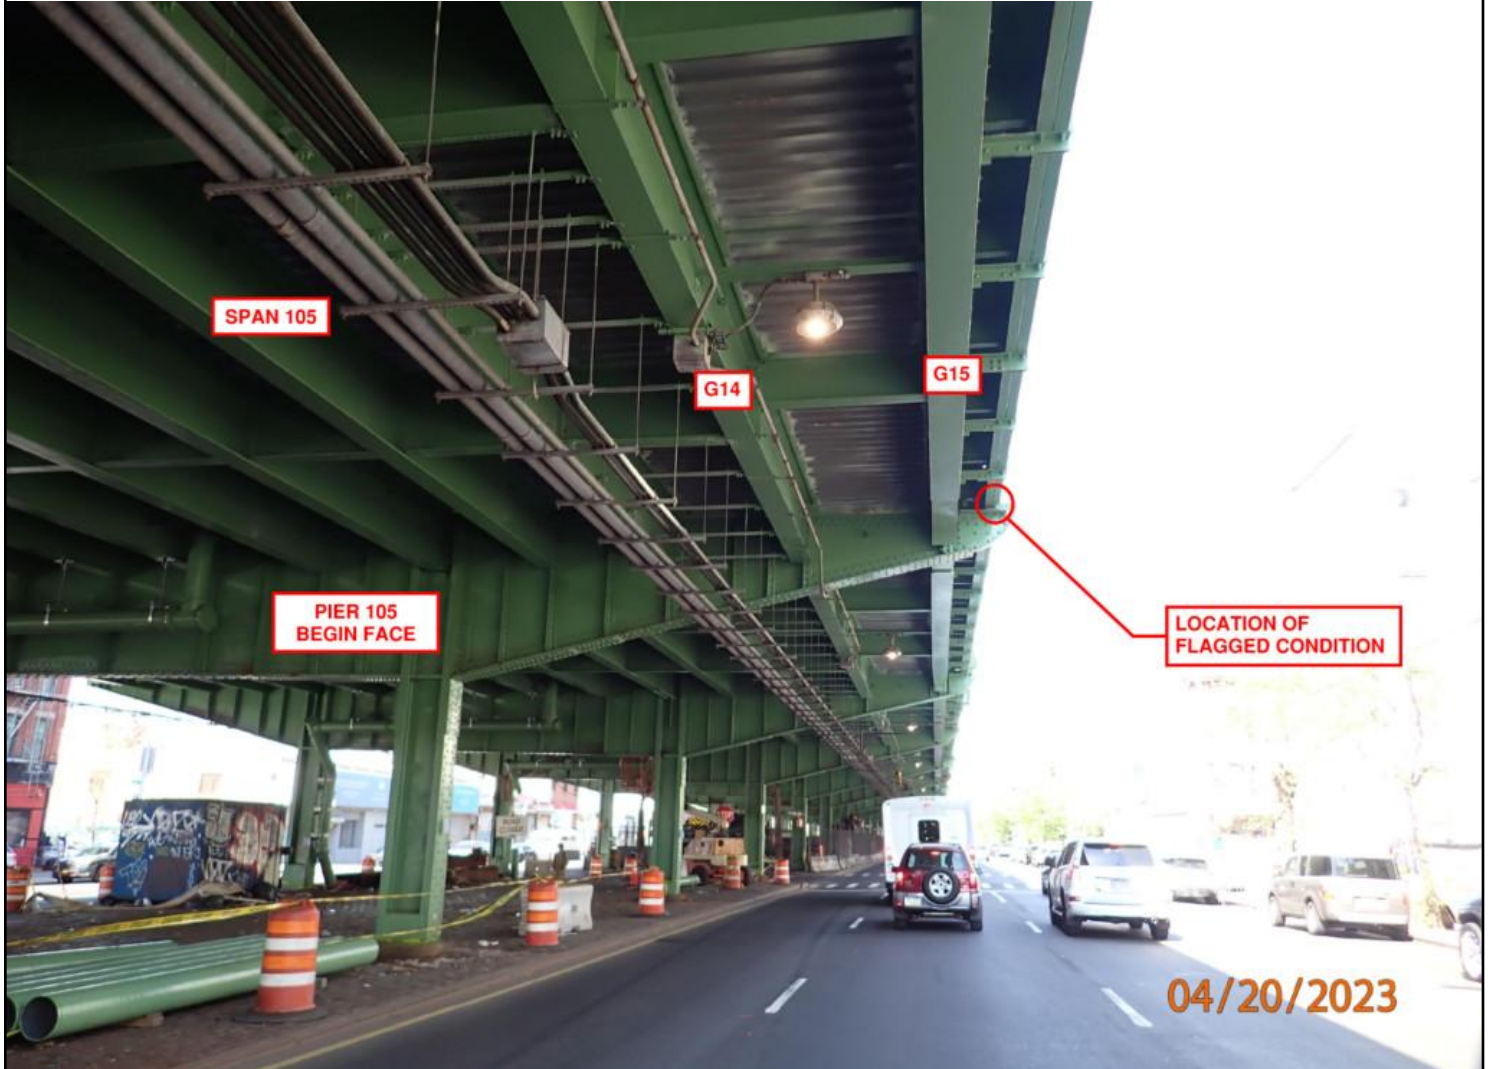
Photo Number: 3

Attachment Description: General view of the flagged condition at Stringer S2 in Span 105 at Pier 105. Looking End

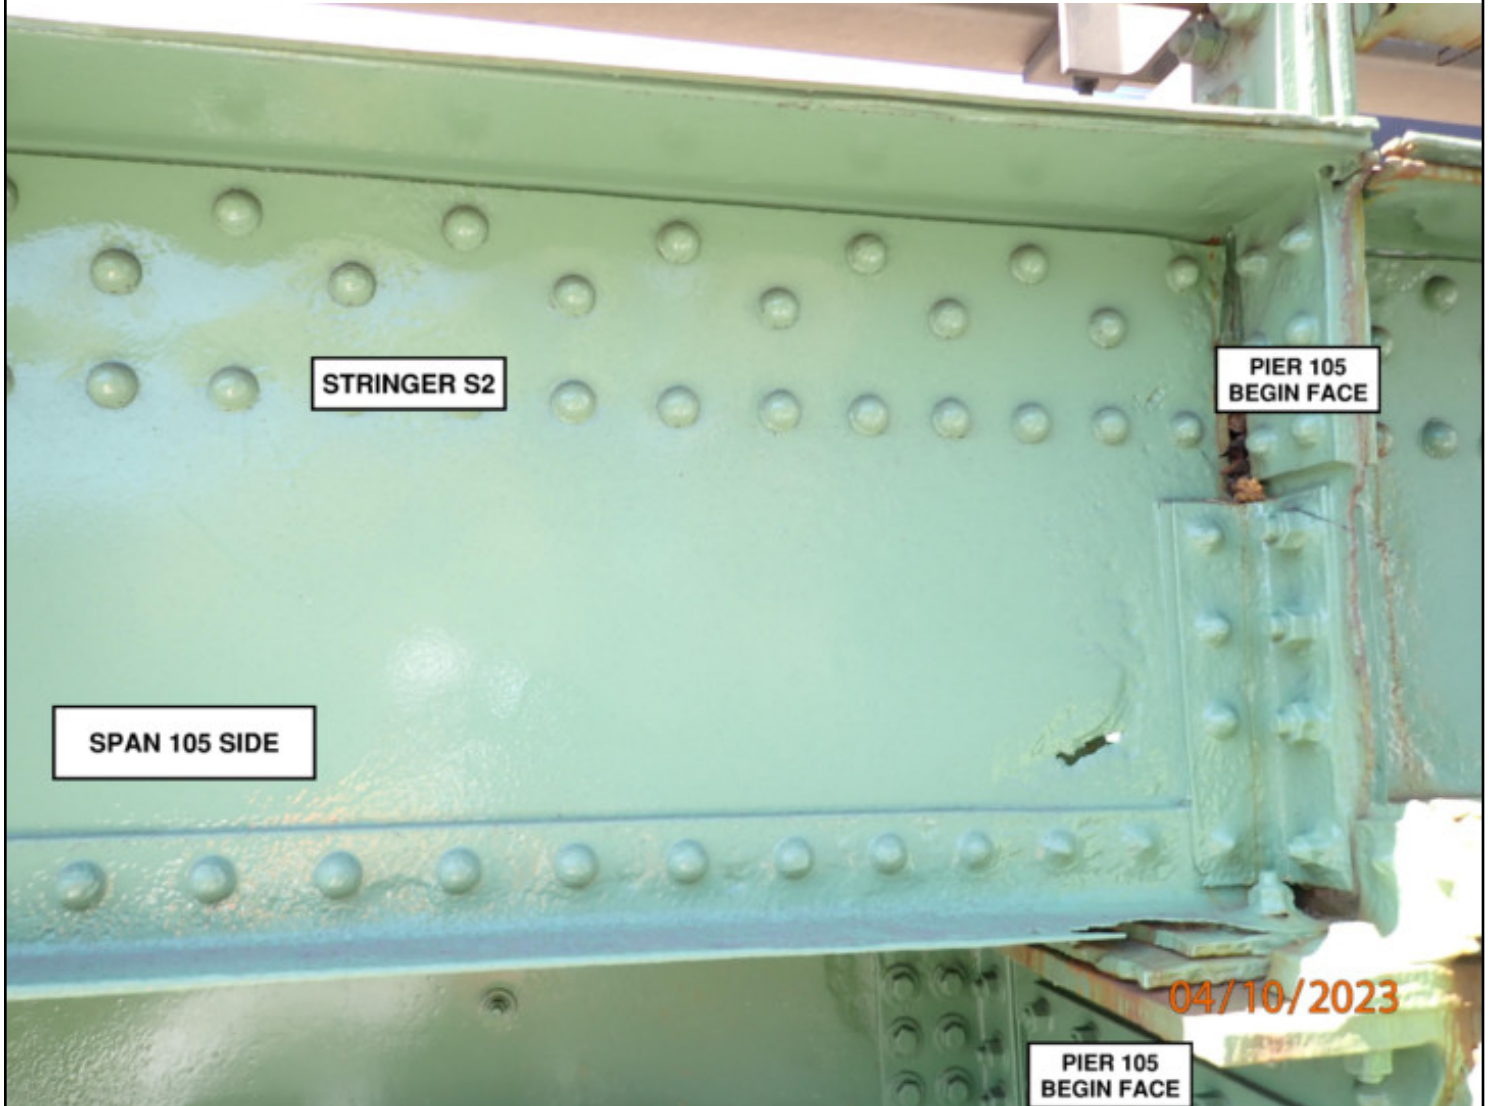
Photo Number: 4

Attachment Description: General View of Stringer S2 end in Span 105 at Pier 105. Looking Left.

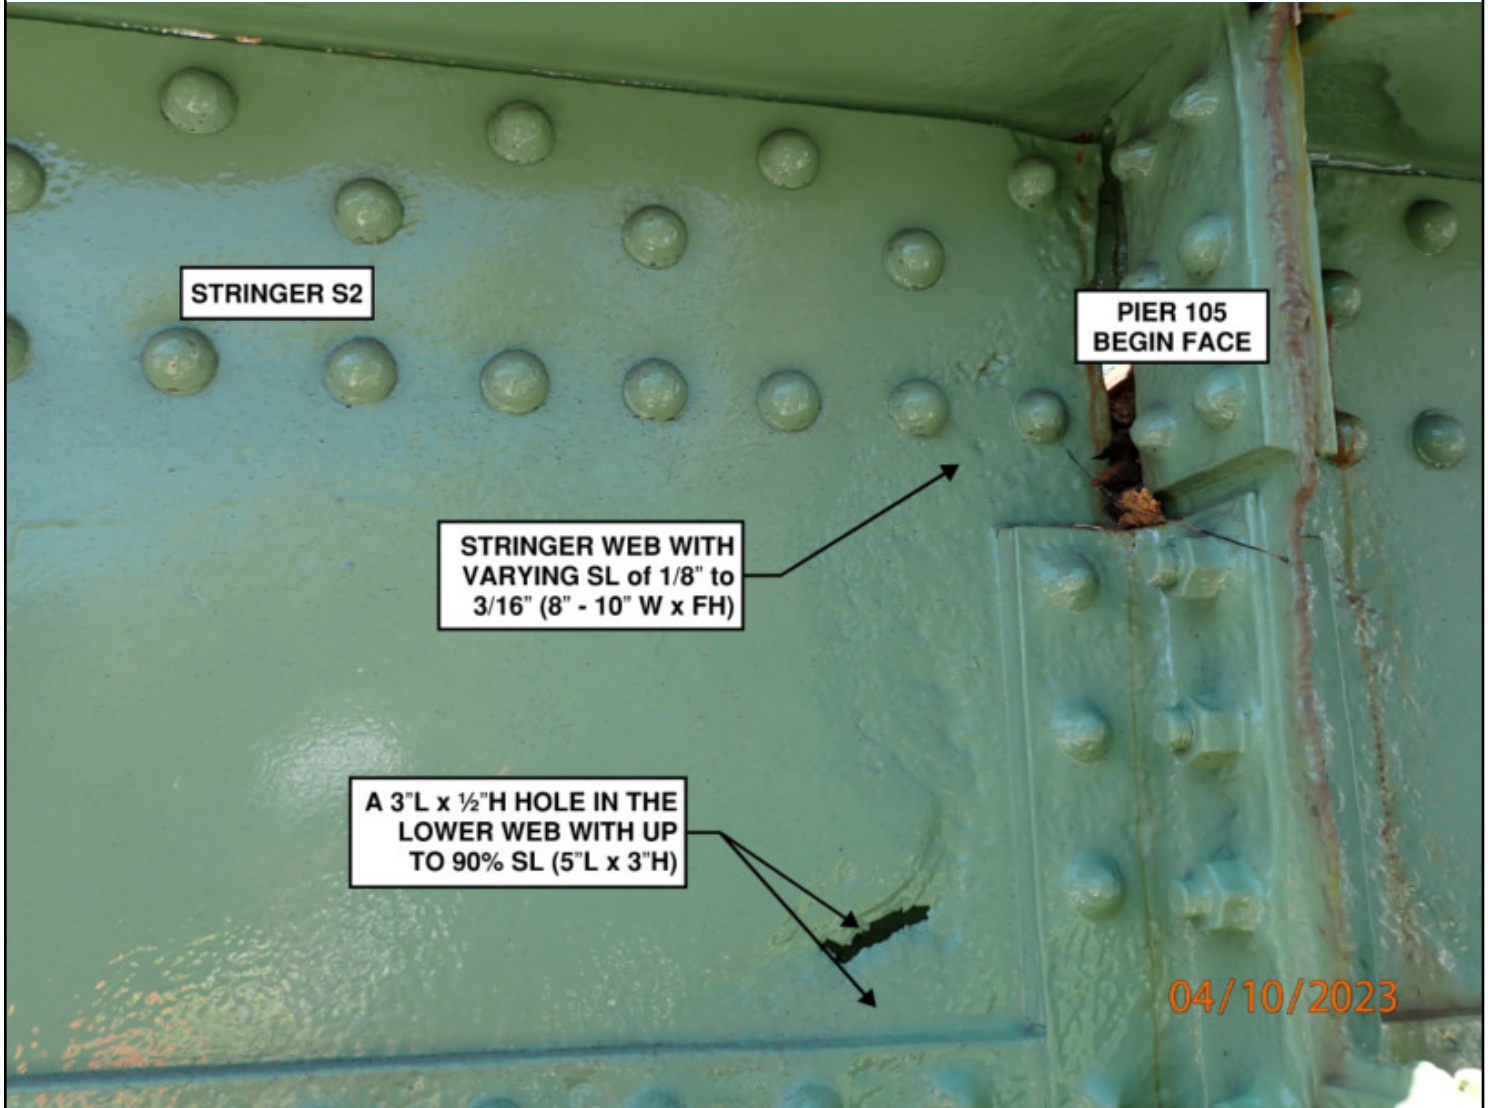
Photo Number: 5

Attachment Description: Close up view of Stringer S2 web at Pier 105, with varying SL of 1/8" to 3/16" over an area of 8" - 10" W x FH (22" H) and a 3"L x 1/2"H hole in the lower web with up to 90% section loss in surrounding area of 5"L x 3"H. Looking Left.

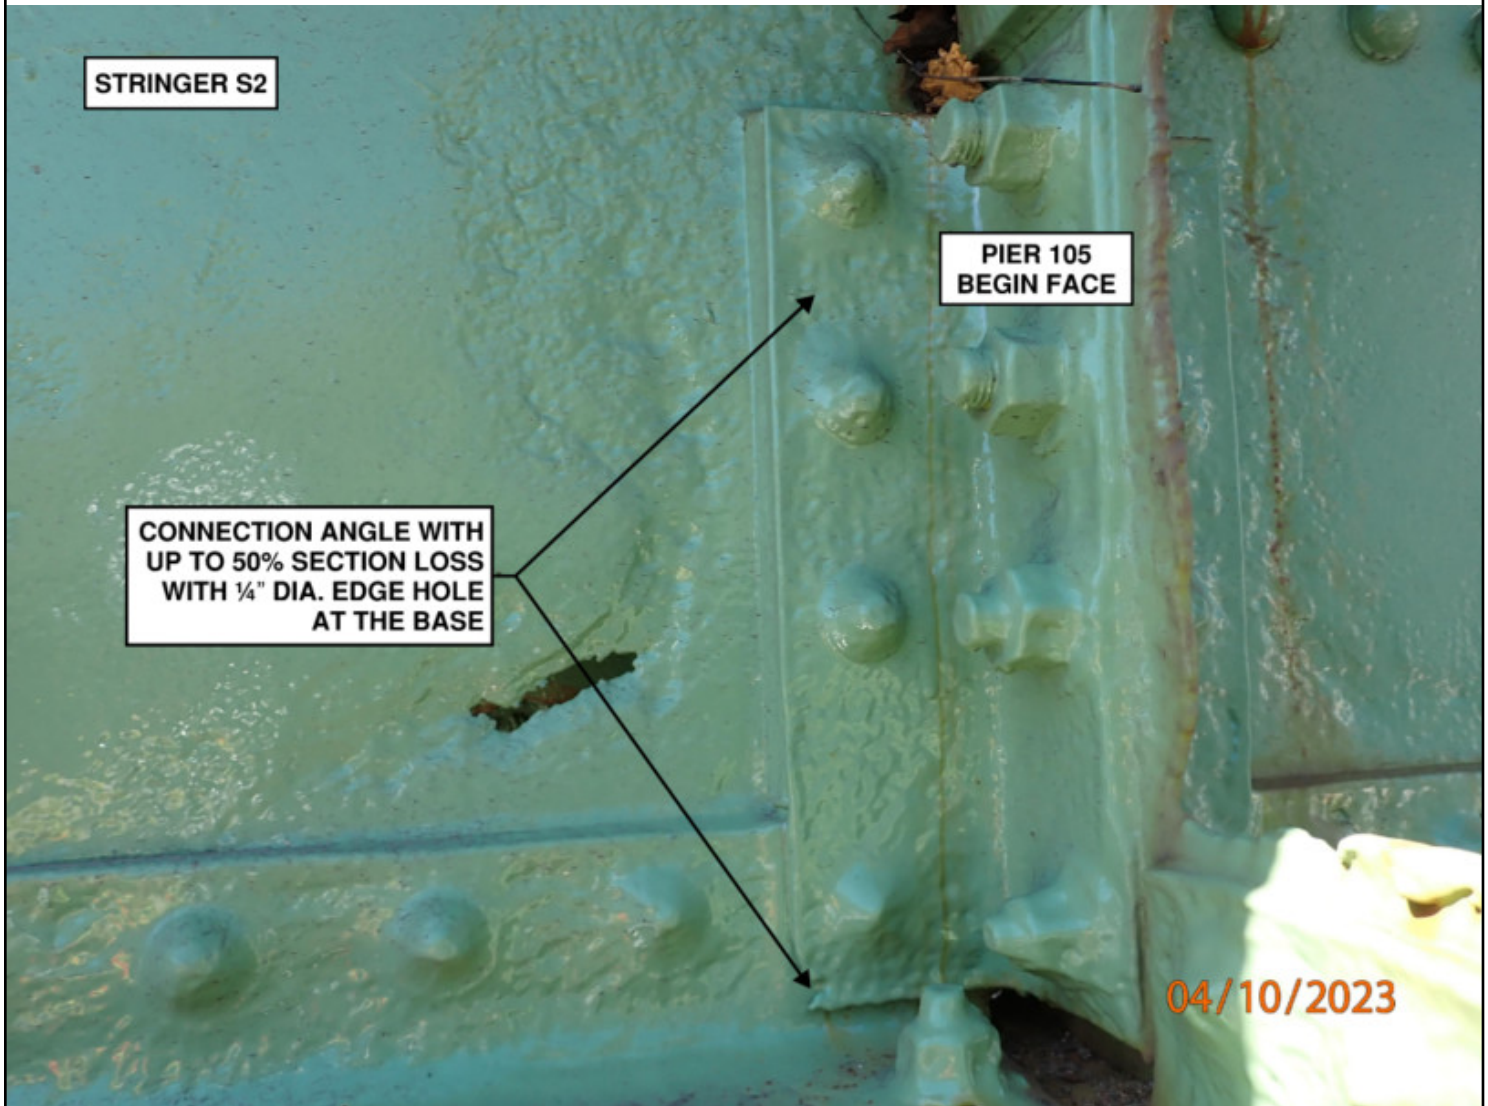
Photo Number: 6

Attachment Description: Close up view of the connection angle of Stringer S2 to Pier 105 at the right face with up to 50% section loss over the full face of the connecting leg with 1/4" dia. edge hole at the base. Looking Left.

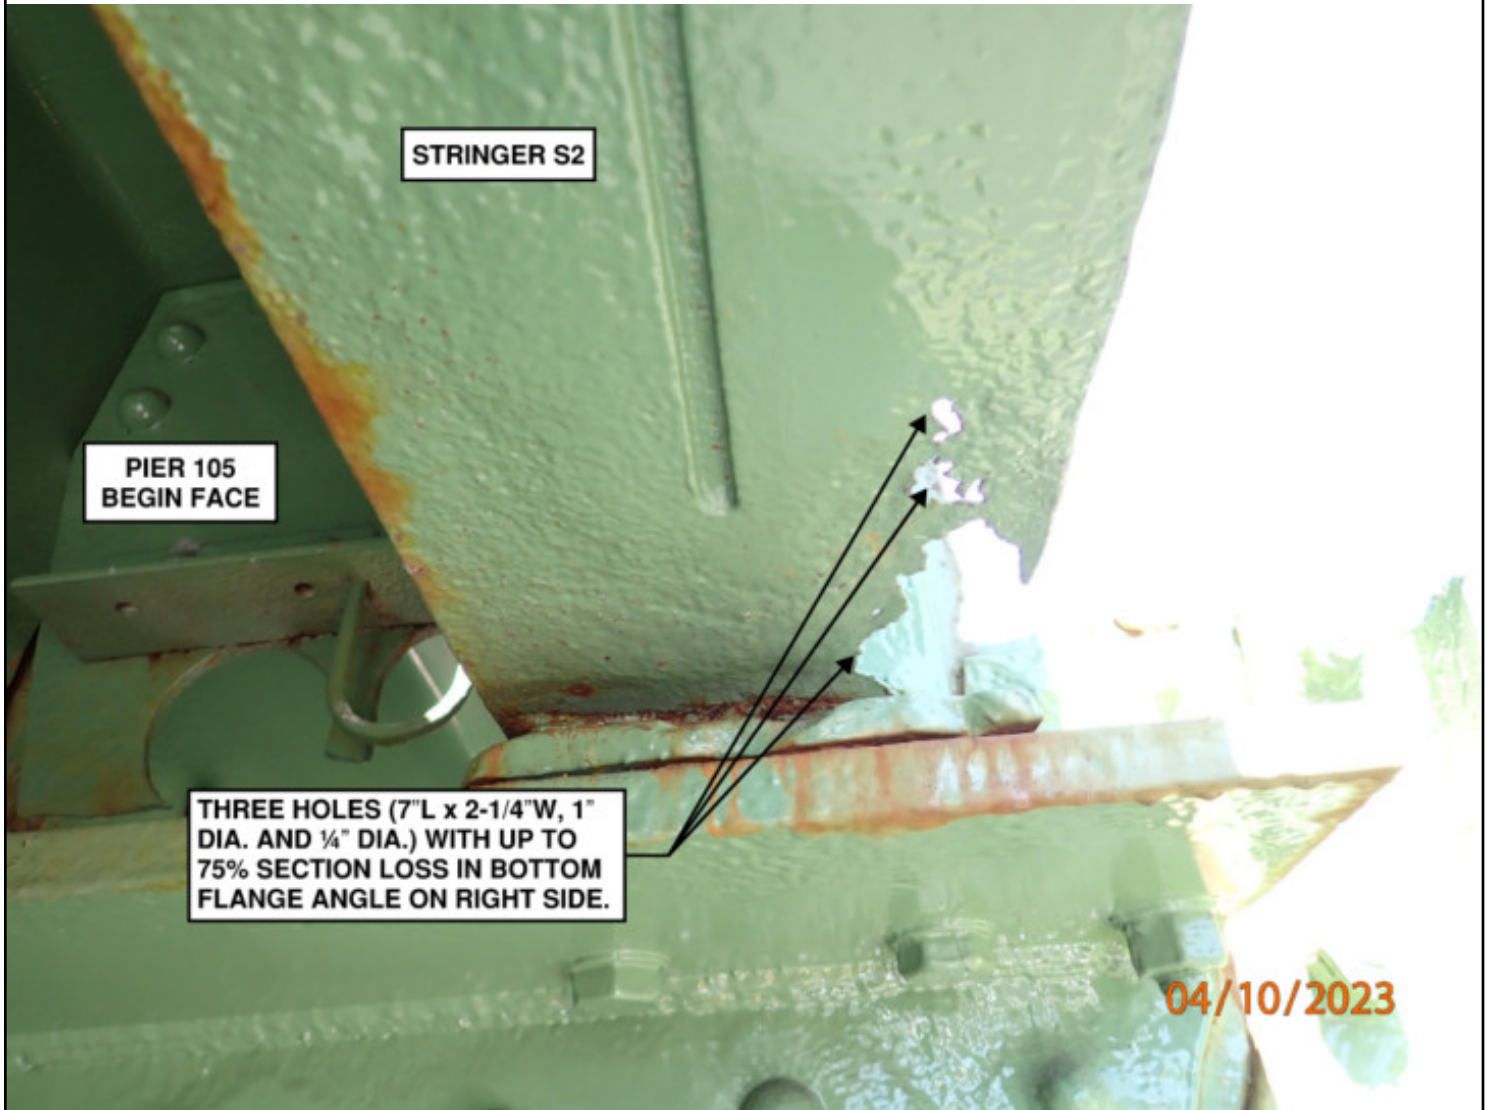
Photo Number: 7

Attachment Description: Close up view of the bottom flange angle on the right side with up to 75% section loss in the outstanding leg (FW x 24"L) with three holes (7"L x 2-1/4"W, 1" diameter and 1/4" diameter) near the stringer seat. The connecting leg of the bottom flange angle on the right side exhibits up to 50% section loss (18"L x FH).
Looking End - Up.
